Results of Electronic Ballot of RESNET Board of Directors on proposed RESNET Standard for Performance Testing to Undergo the RESNET Amendment Public Review and Comment Process

June 15, 2009

800 RESNET Standard for Performance Testing

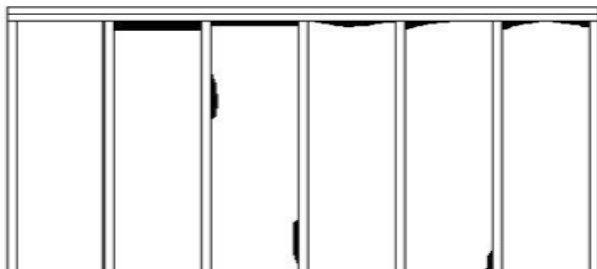
Grade II must be insulation installed with anomalies found to be between ½% and 2% for all inspected walls, floors and ceilings of the building.

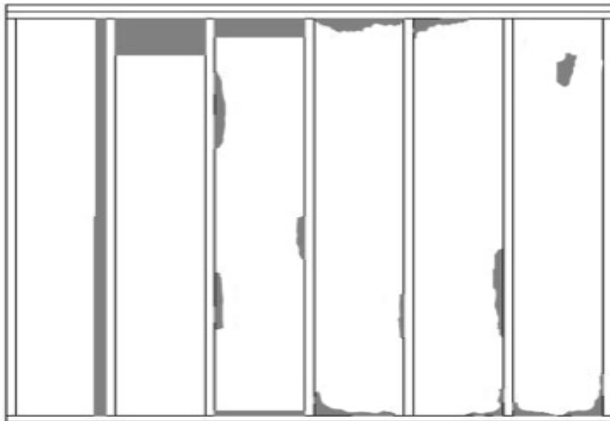
Grade III must be an insulation installation having between 2% and 5% anomalies found for all inspected walls, ceilings and floors of the building enclosure.

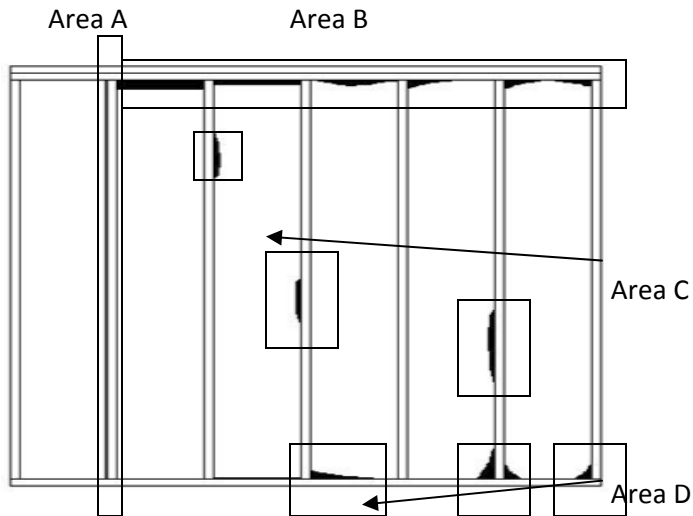
Grade II Example

Wall section is 8 ft x 8 ft.

Area A: $\frac{1}{2}'' \times 96'' = 0.33$ sqft

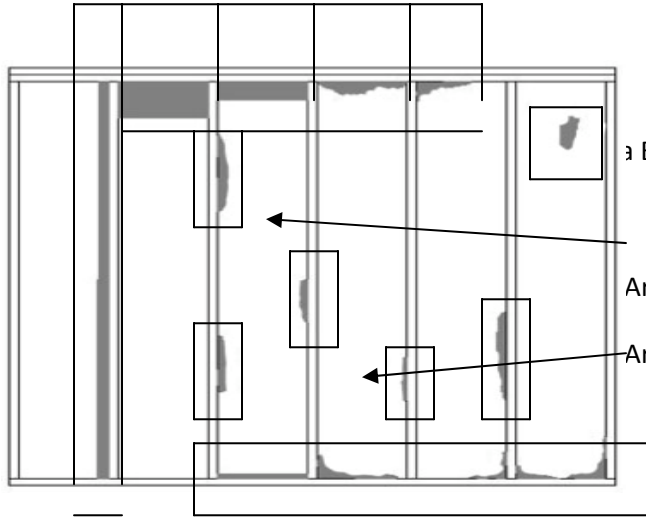
Areas: A B C D E

Wall section is 8 ft x 8 ft.

Area A: 1"x96" = 0.67 sqft

Area B: 3"x16" = 0.33 sqft

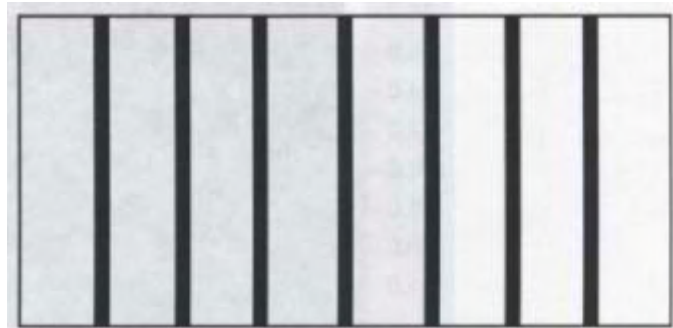
1. Different thermal patterns occur as a result of differing wall conditions, which must be identified for proper interpretation of the thermographic images. Without knowing the exact conditions you are viewing with the camera (summer/winter, inside/outside, transient state/steady state), you cannot make the proper interpretation of the thermogram. The following general descriptions of exterior walls do not take into account any obstructions, which may be within the wall cavities.
 - a. The wall below with warm (lighter) wall cavity areas and cold (darker) framing materials could be one of the following:
 - Uninsulated, when viewed from outside during the heating season.
 - Insulated, when viewed from inside during the heating season.
 - Insulated, when viewed from the outside during the cooling season.
 - Uninsulated, when viewed from the inside during the cooling season.

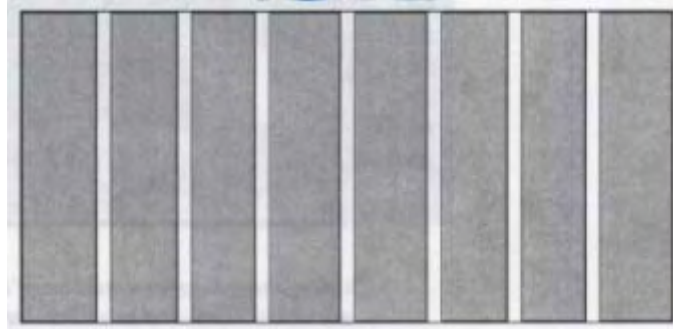
- b. The wall below with darker (cooler) wall cavity areas and warmer (lighter) framing materials could be one of the following:
 - Insulated, when viewed from the outside during the heating season.
 - Uninsulated, when viewed from the inside during the heating season.
 - Uninsulated, when viewed from the outside during the cooling season.
 - Insulated, when viewed from the inside during the cooling season.
